Australian Building Codes Board

Fire safety in car parks

Literature review

Reference: 296877-ABCB-ARUP-Fire safety in car parks

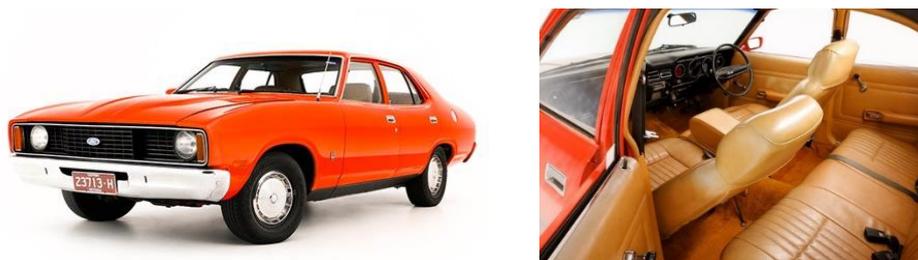
Figure 7: Images of the model of car used as the test car in the first of the BHP open-deck experiments. Note the car has metal grilles, hub caps, and no plastic wing mirrors. © Trade Unique Cars. Available at: <https://www.tradeuniquecars.com.au/feature-cars/1804/1978-ford-falcon-xc-500-review>.

The model of test car in test one (a Ford Falcon XC Sedan) had a length of 4.9 m, width of 1.9 m and height of 1.4 m. It has a curb weight of 1,475 kg [50]. An example of this car model is shown in Figure 7. It is worth noting that this earlier 1979 car didn’t have much plastic on its exterior, whereas the 1982 Ford Falcon XD Sedan used in the second test did.

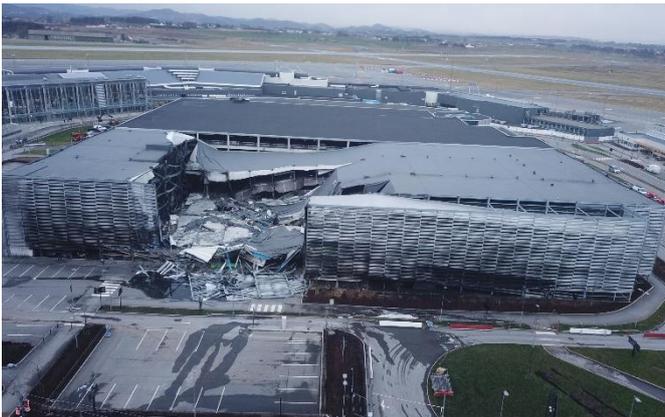
Date:	07/01/2020
Location:	Stavanger, Norway
Vehicles involved:	200
Carpark type:	Open-deck
Storey area:	18,500 m ²
Sprinklered?	No
Smoke exhaust?	No
Injuries:	0
Fatalities:	0

Figure 13: Stavanger airport carpark collapse after the fire.
Reproduced from [60]. © Nordic Unmanned.

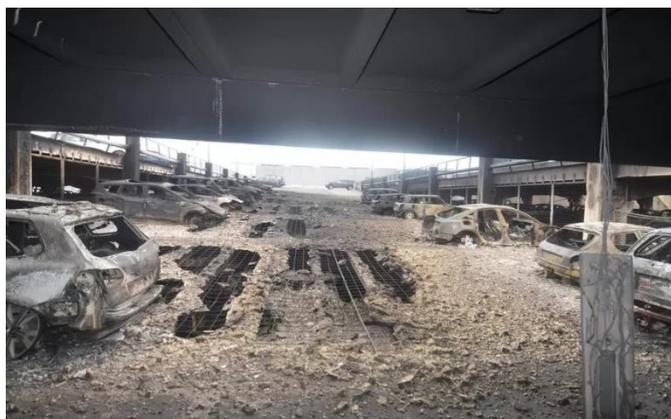
Date:	31/12/2017
Location:	Liverpool, UK
Vehicles involved:	1,150
Carpark type:	Open-deck
Storey area:	5,000 m ²
Sprinklered?	No
Smoke exhaust?	No
Injuries:	0
Fatalities:	0

Figure 14: Echo Arena carpark after the fire. Reproduced from [62]. © Merseyside Fire and Rescue Service (MF&RS).

The building had a 15-minute FRL. Remarkably, the concrete structure remained standing after the fire, even though there were clear signs of explosive spalling, floor failure and structural element damage (see Figure 14). The entire building has subsequently been demolished [62], [63], [64], [65].

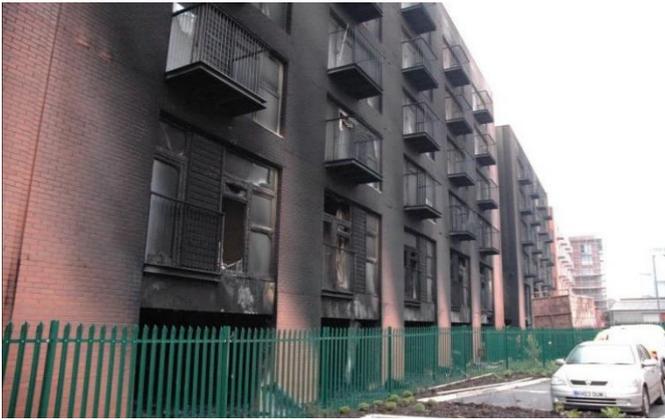
Date:	20/12/2006
Location:	Bristol, UK
Vehicles involved:	22
Carpark type:	Underground, open on two sides
Storey area:	3,000 m ²
Sprinklered?	No (residential area was)
Smoke exhaust?	No
Injuries:	0
Fatalities:	1

Figure 15: Monica Wills House after the fire. Reproduced from [68]. © Avon Fire and Rescue Service (AFRS).

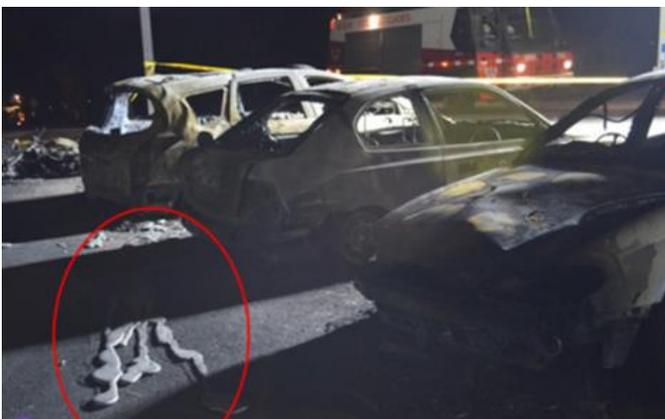
Date:	13/10/2013
Location:	Sydney, Australia
Vehicles involved:	80
Carpark type:	Open air
Storey area:	23,000 m ²
Sprinklered?	Not applicable
Smoke exhaust?	Not applicable
Injuries:	0
Fatalities:	0

Figure 16: Molten aluminium from one of the cars involved in the Sydney Aquatic carpark fire. Reproduced from [70].
